REPORT ON RIVER GAGE STATION

LOCATION: Portola
STREAM: Middle Fork Feather River
BASIN: Feather River HSA: REV

LOCATION IDENTIFICATION: MFTC1
NWS INDEX NUMBER:
USGS NUMBER: 11392100

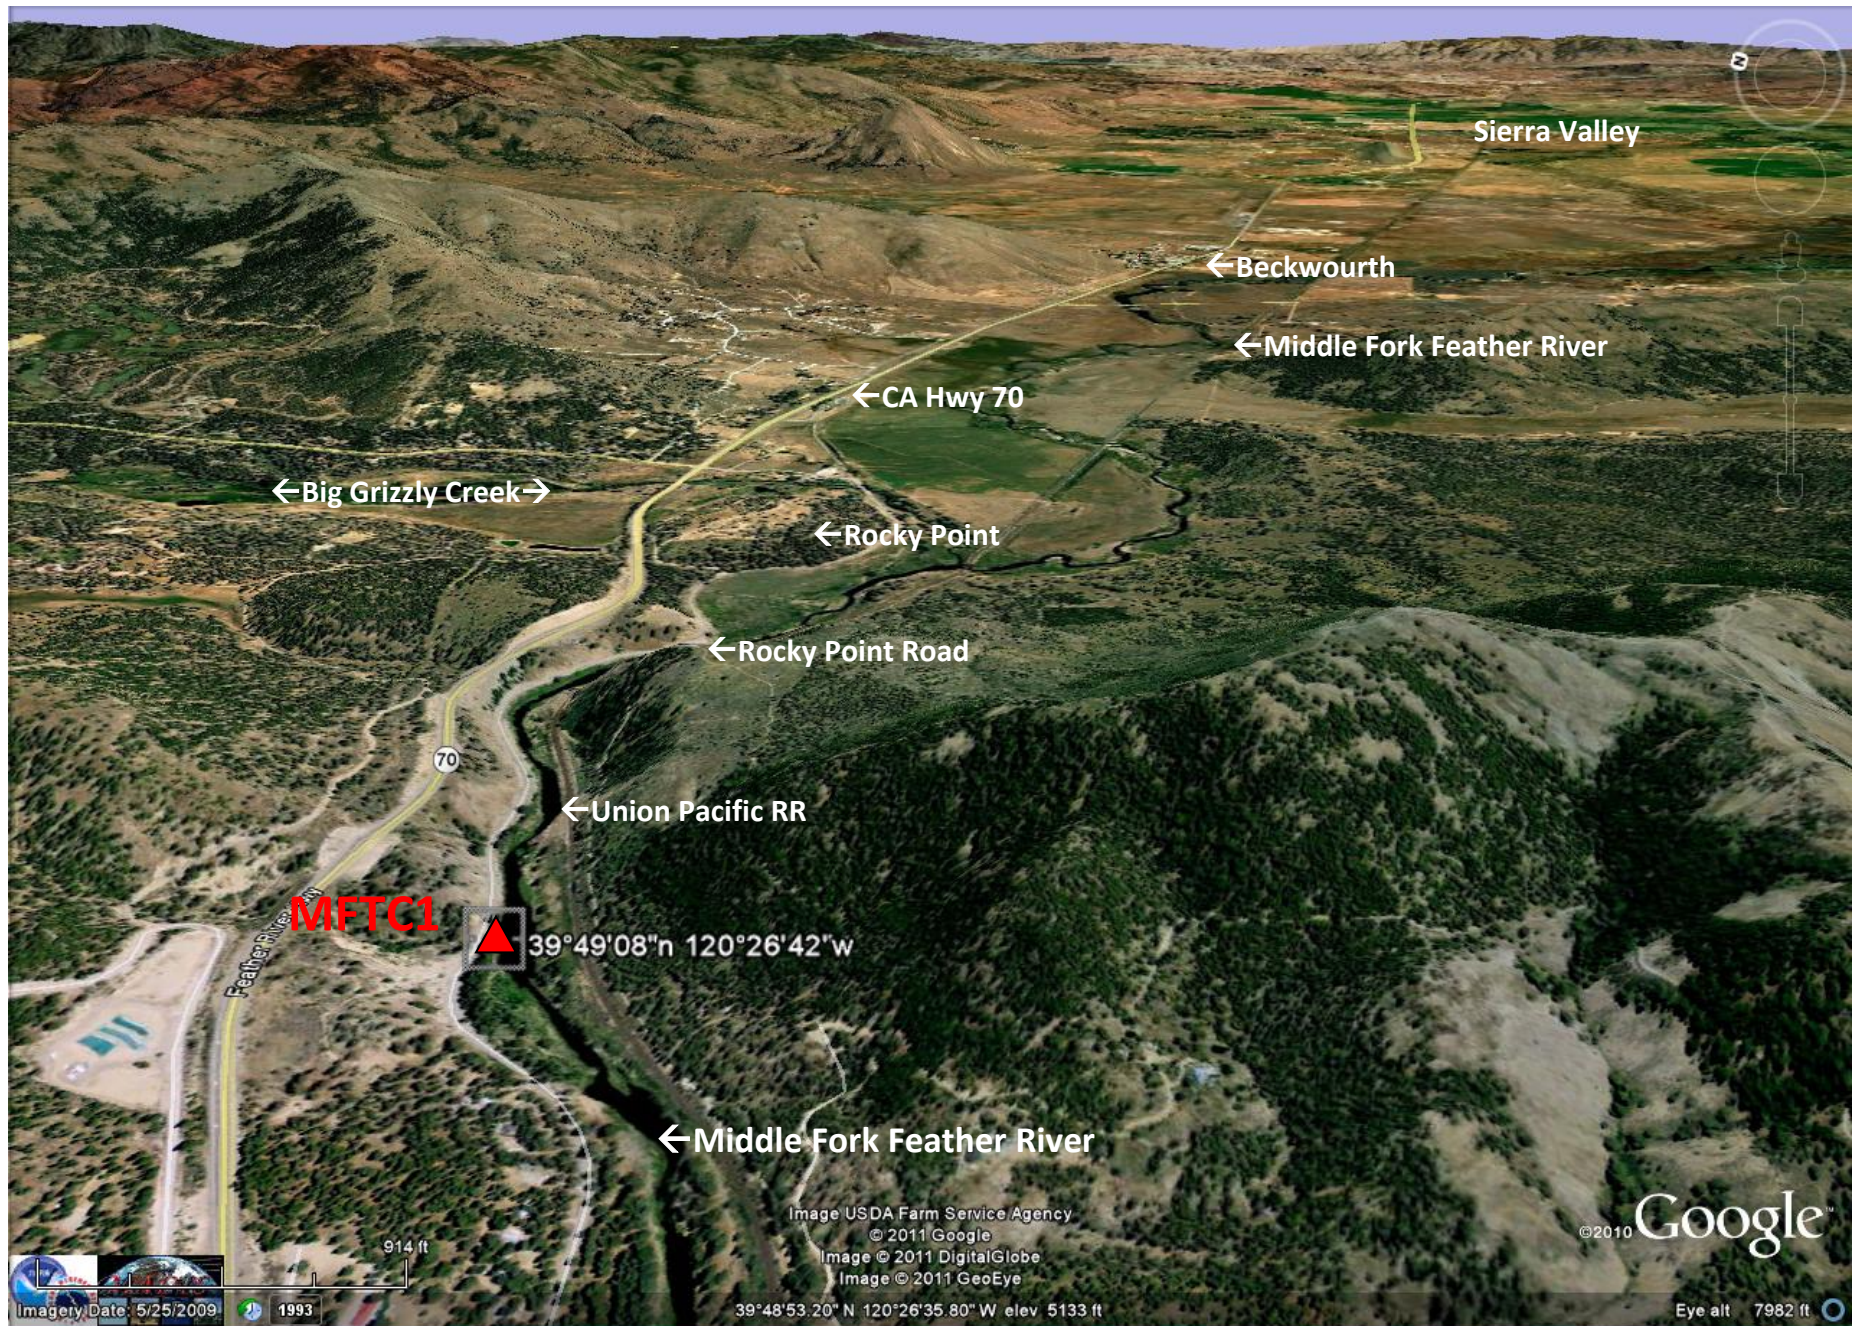
Aerial view of Middle Fork Feather River, from just west of gage east to the Sierra Valley. View is to ENE.
Middle Fork Feather River near Portola CA (MFTC1) HSA: REV October 2011 Page 4

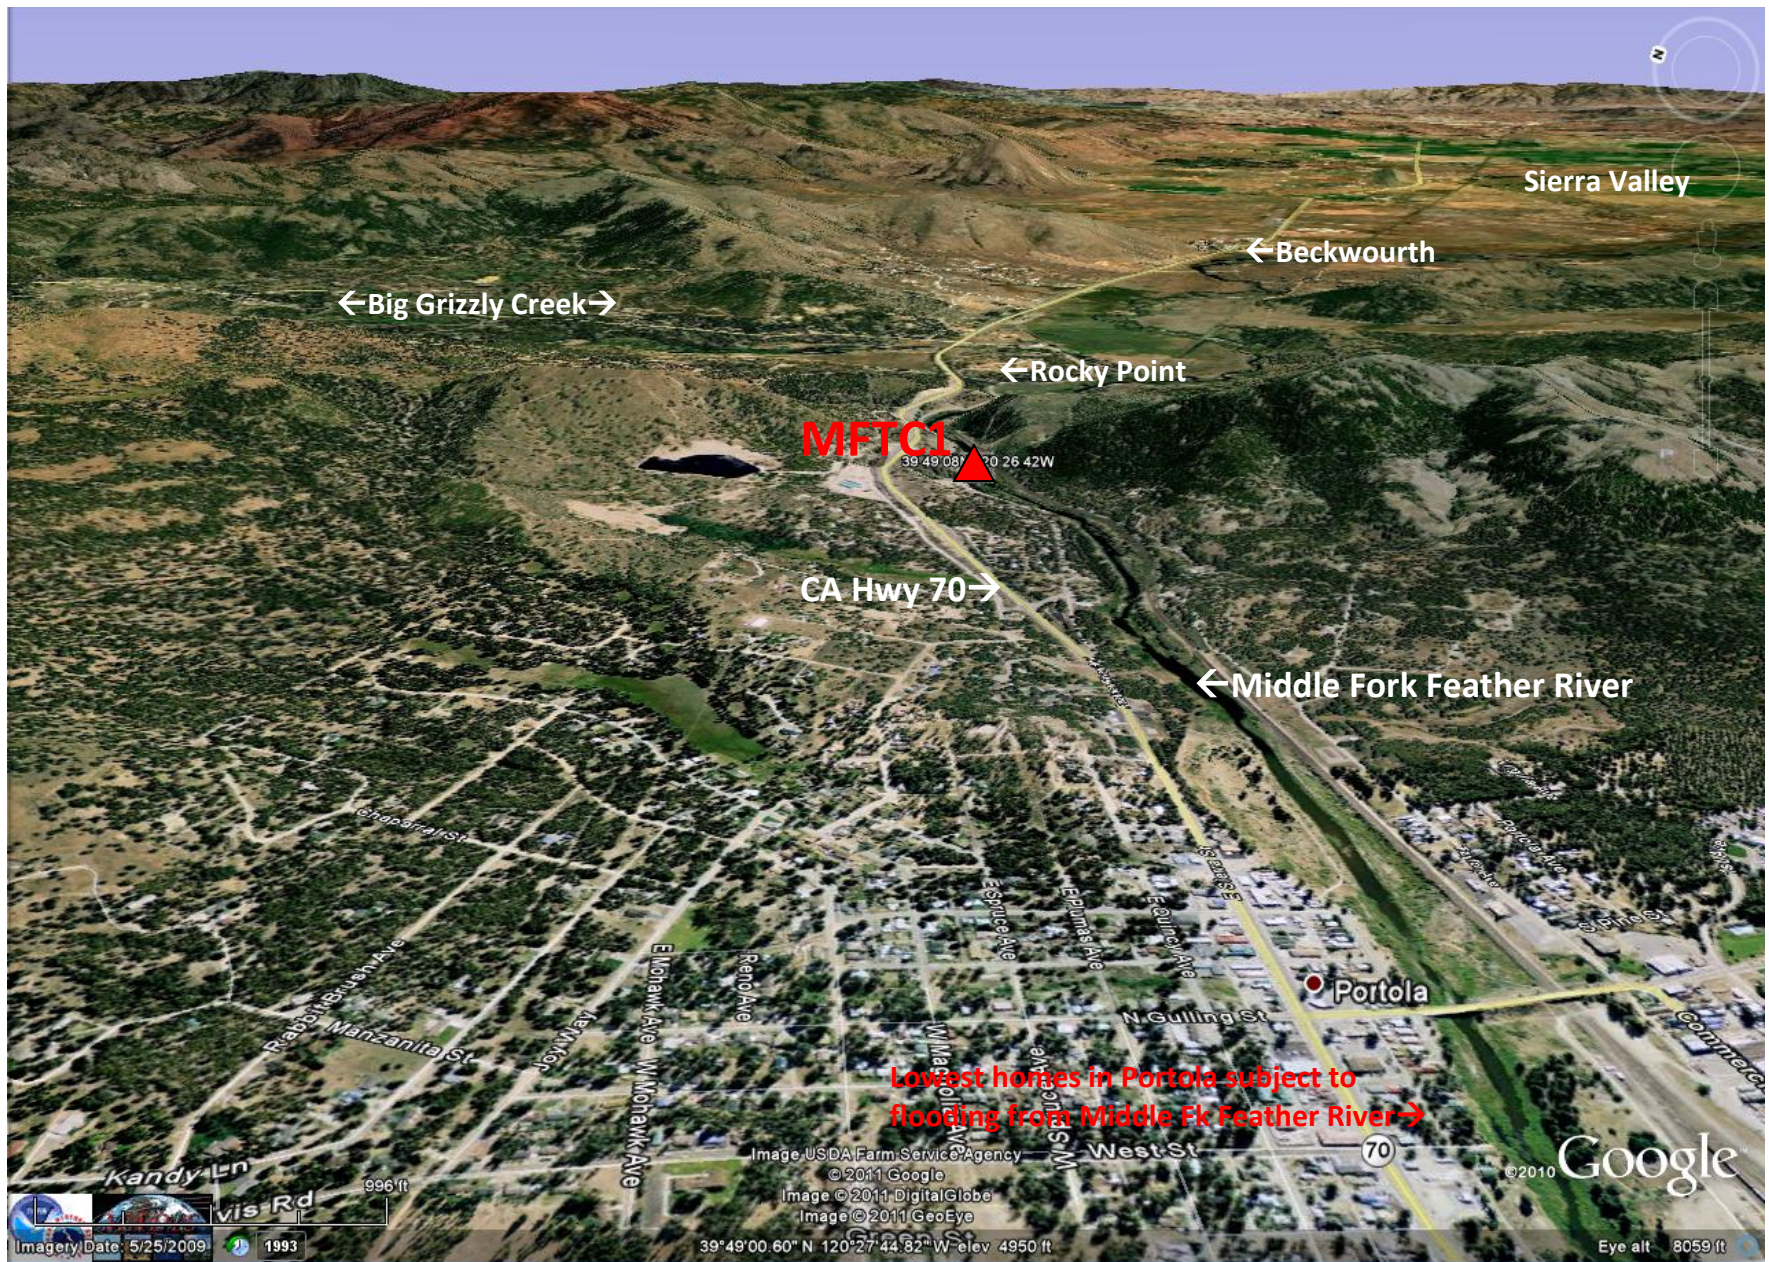
Aerial view of Middle Fork Feather River Valley, from Portola east to the Sierra Valley. View is to ENE.

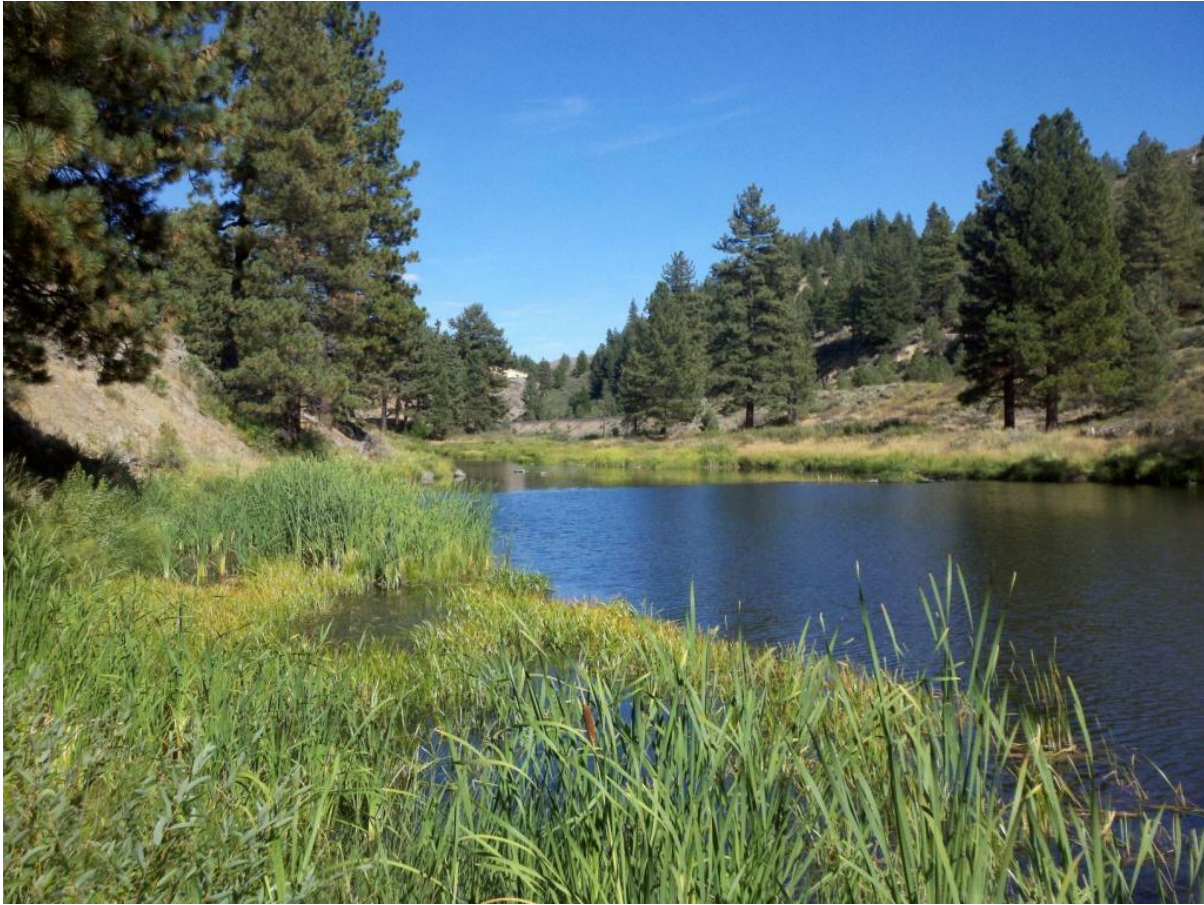
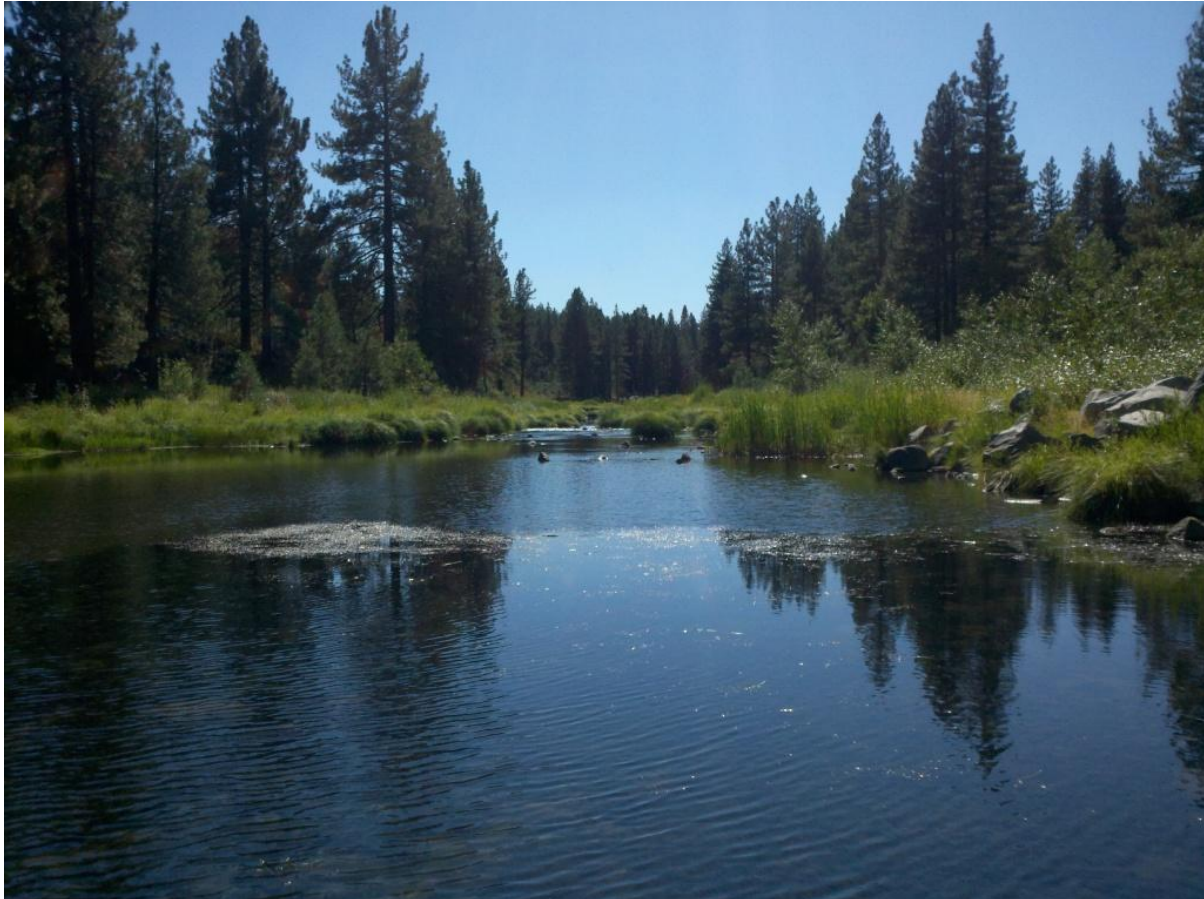
Photos: Middle Fork Feather River near Portola, CA: Gage Location; Low Flow

Top: US view (ENE); Bottom: DS view (SW) from near gage on RB; 9/19/2011, stage 1.90', flow ~18 cfs.
(Photos above provided by Wayne Ables, CA DWR Engineer, Red Bluff, CA)

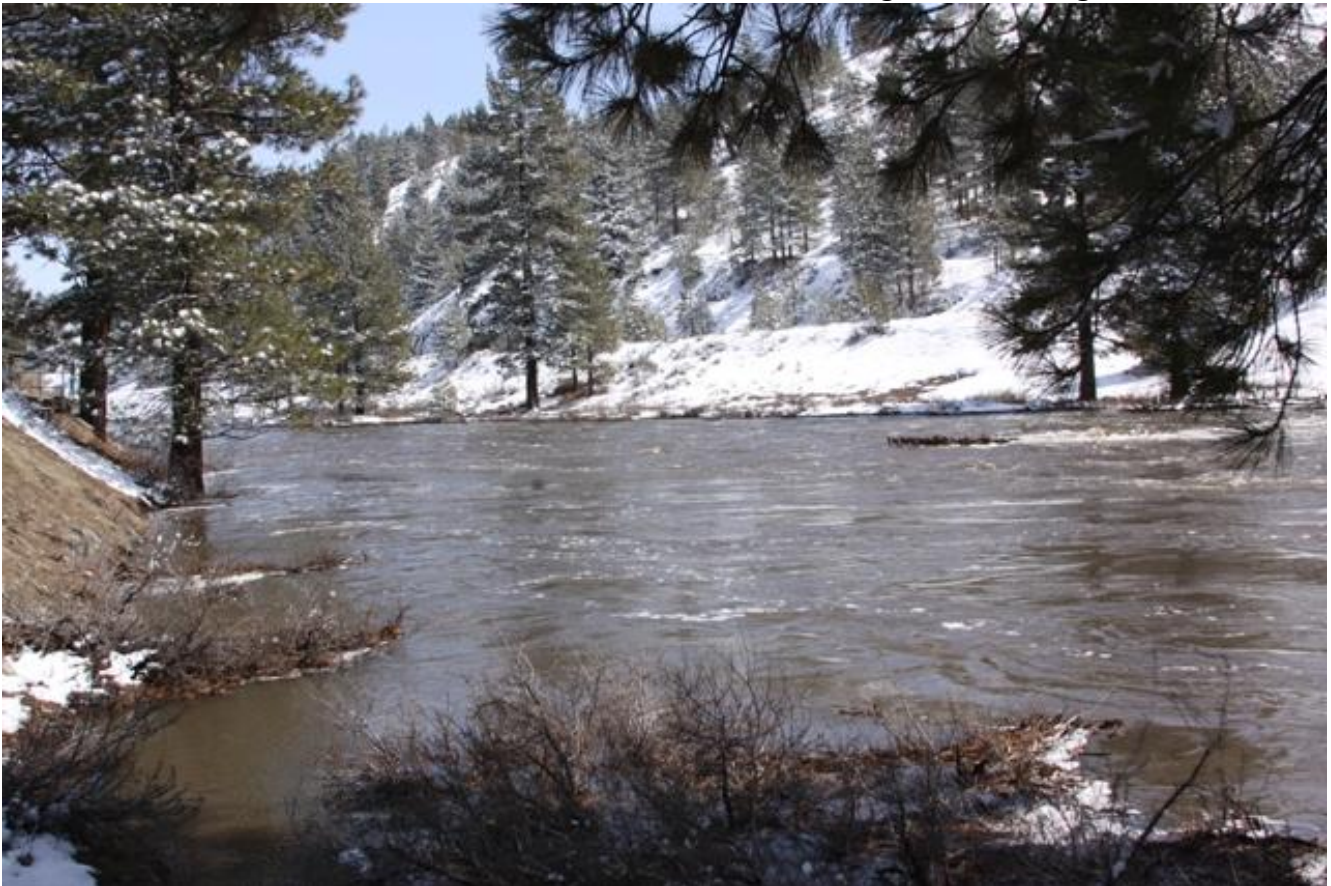
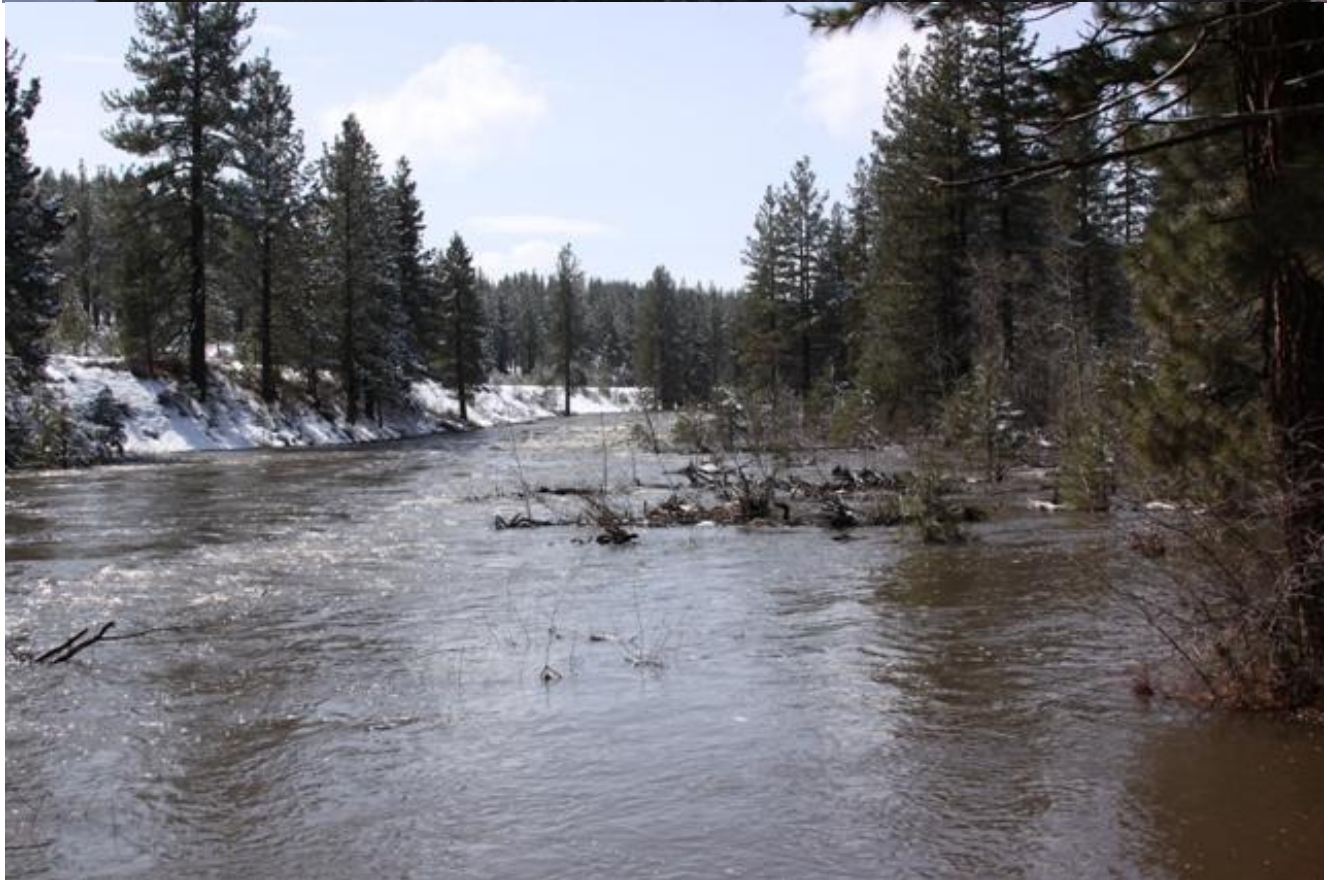
Photos: Middle Fork Feather River near Portola, CA: Gage Location; High Flow

Top: US view (ENE); Bottom: DS view (SW); from near gage on RB.
3/17/2011, 1245PM; Stage: 9.01', Flow: ~4820 cfs

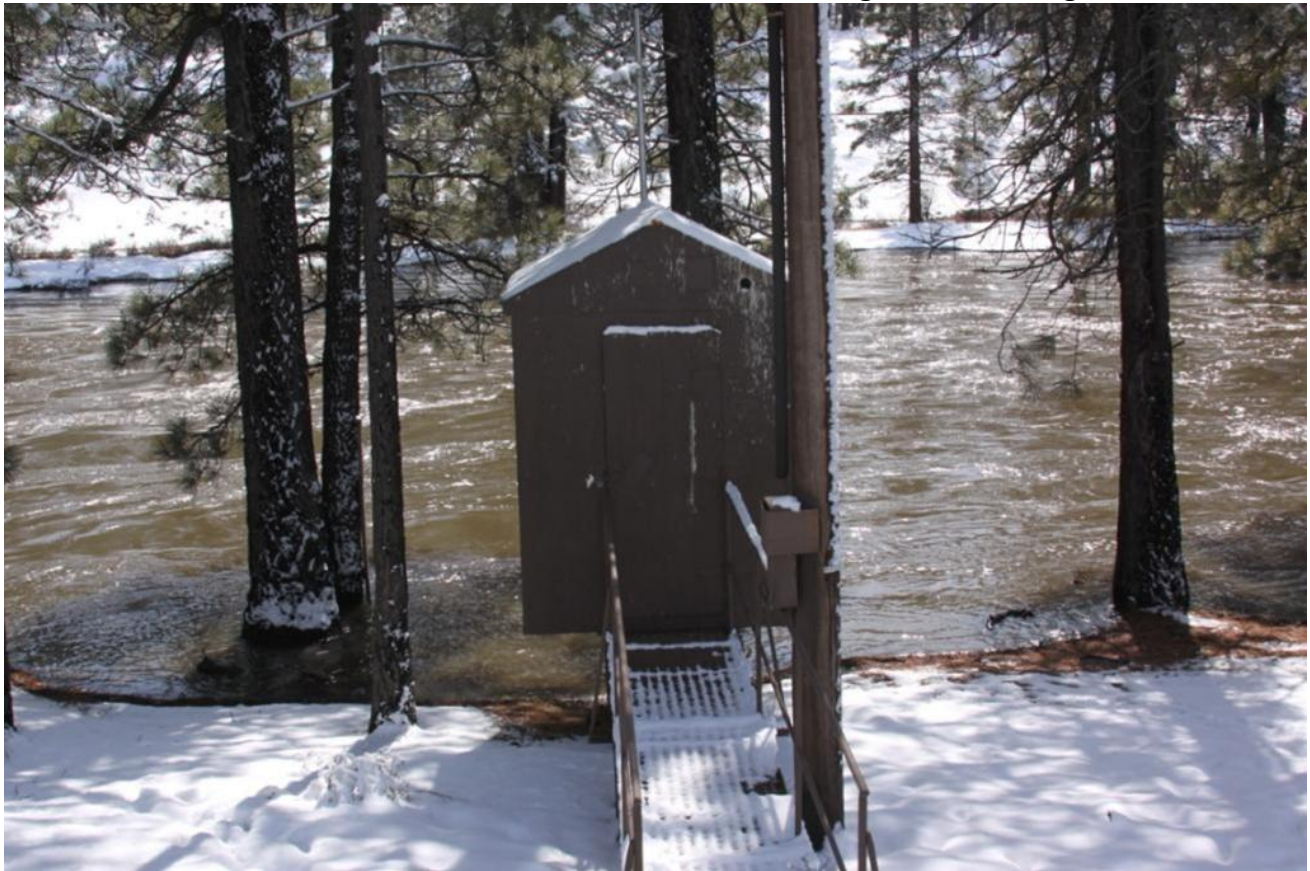
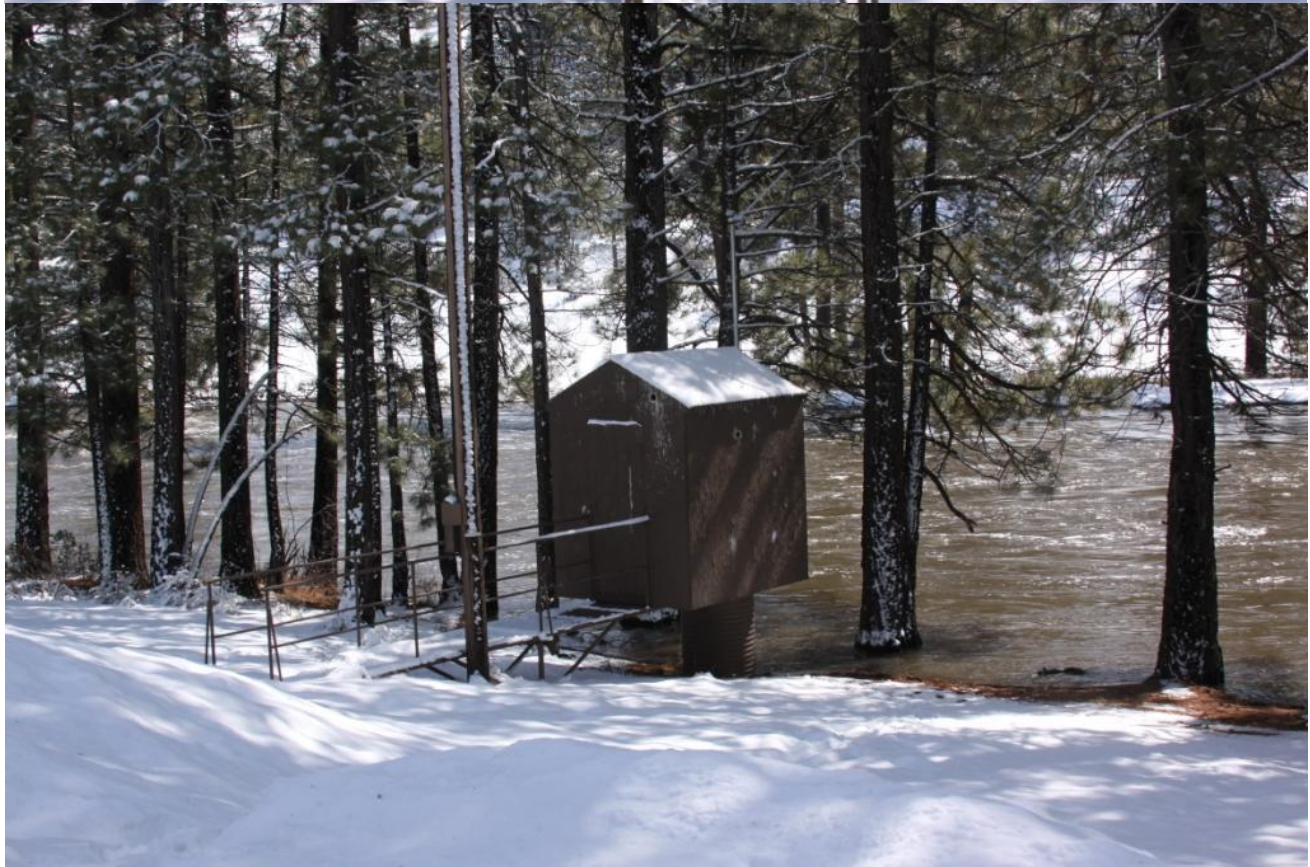
Photos: Middle Fork Feather River near Portola, CA: Gage Location; Gage House

Views of MFTC1 gage house 3/17/2011, 1245PM; Stage: 9.01', Flow: ~4820 cfs.

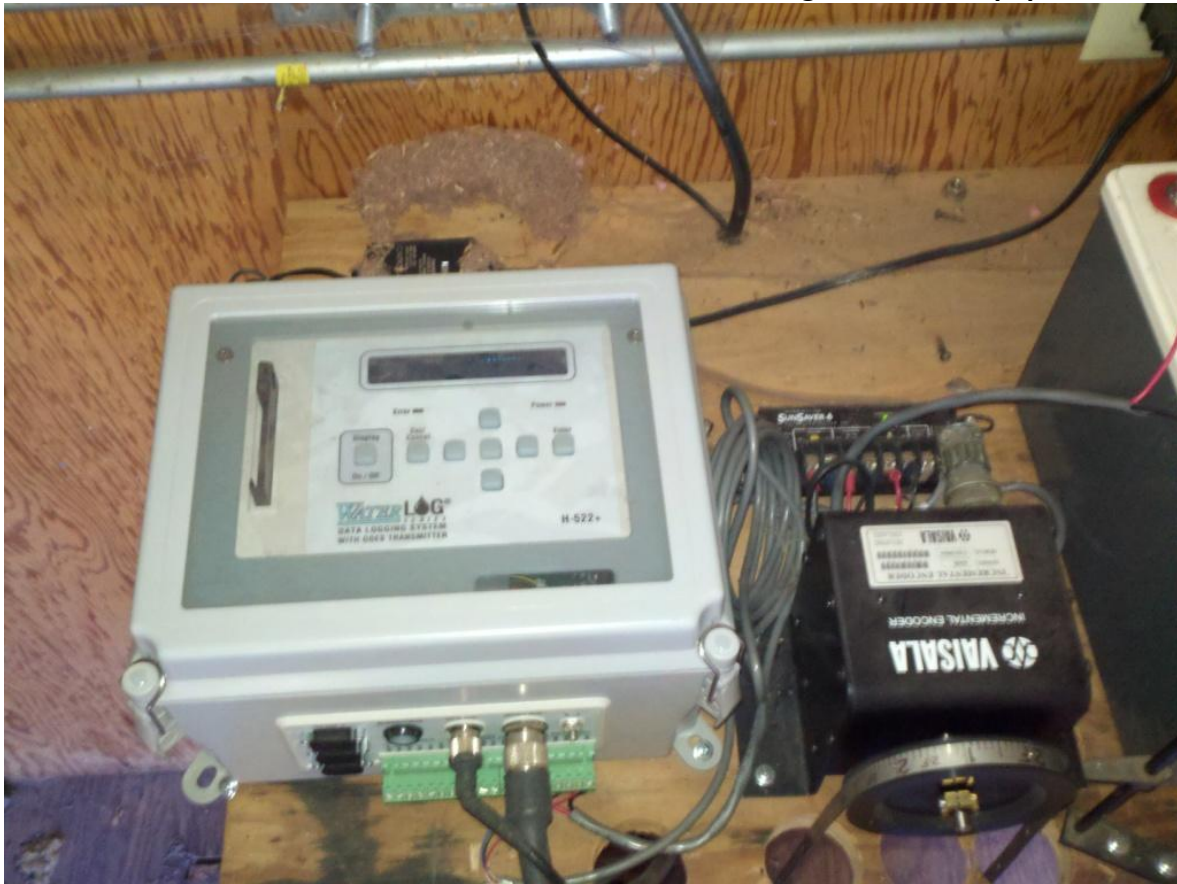
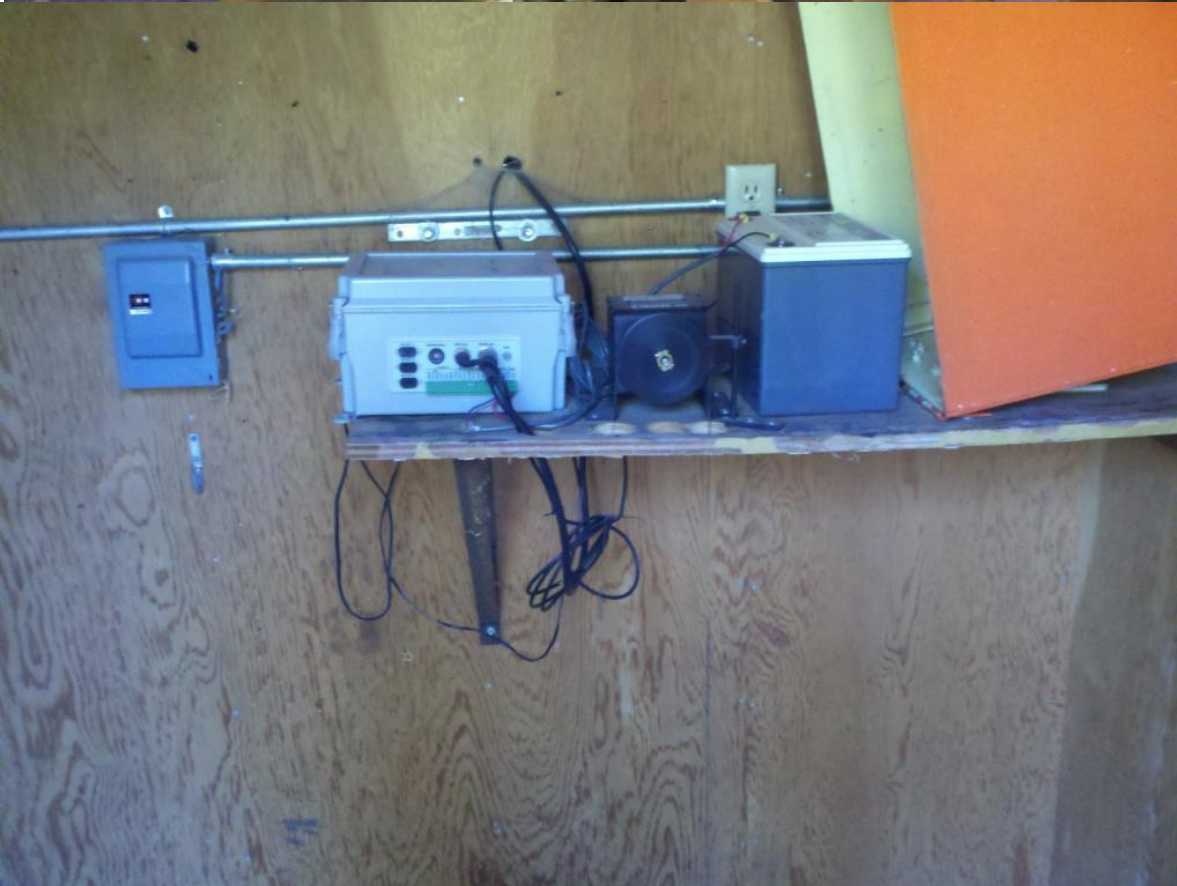
Two views of equipment in MFTC1 gage house: Design Analysis 522+ Waterlog DCP & recorder (left) driven by Vaisala shaft encoder and float tape (center), battery is on right.
(Photos above provided taken 9/19/2011 by Wayne Ables, CA DWR Engineer, Red Bluff, CA)

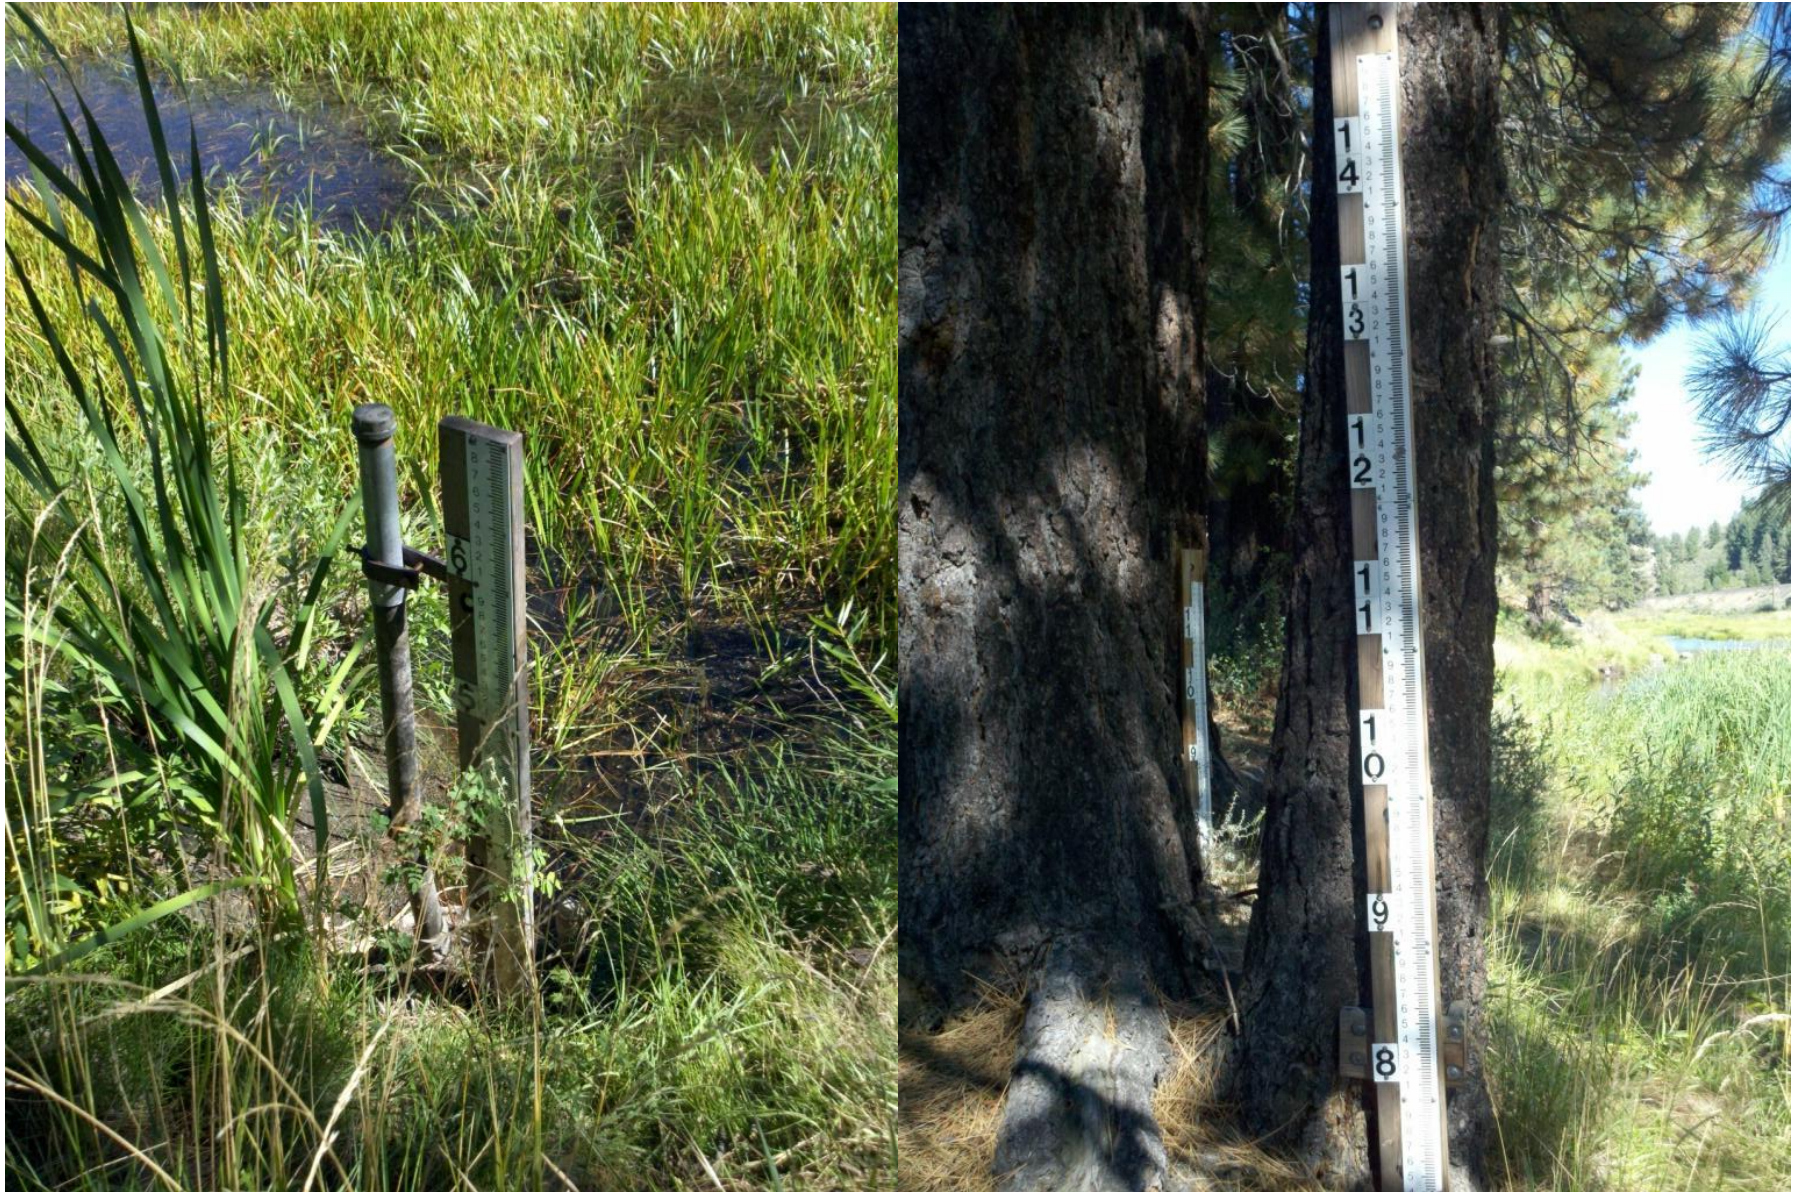
Photos: Middle Fork Feather River near Portola, CA: Gage Location, Staff Gages

Left: Lower MFTC1 staff gage, range: 1.0'-6.92'. Right: Upper MFTC1 staff gage, range: 7.4'-15.0' (Middle staff visible behind and to left of upper staff). Photos above taken 9/19/2011, stage 1.90', flow ~18 cfs by Wayne Ables, CA DWR Engineer, Red Bluff, CA

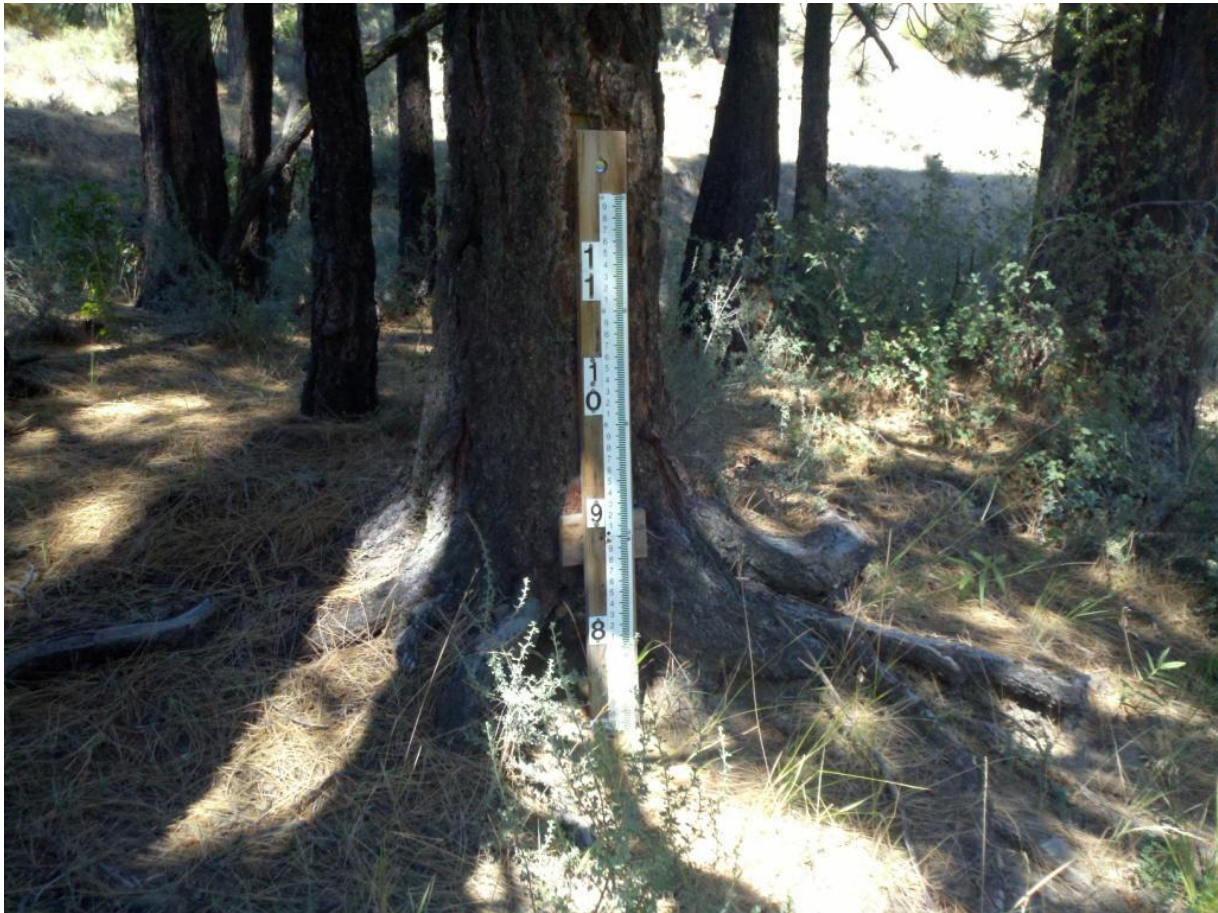
Photos: Middle Fork Feather River near Portola, CA: Gage Location, Staff Gages

Middle MFTC1 staff gage, range: 7.2' to 12.0'. (9/19/2011 by Wayne Ables, CA DWR Engineer, Red Bluff, CA)

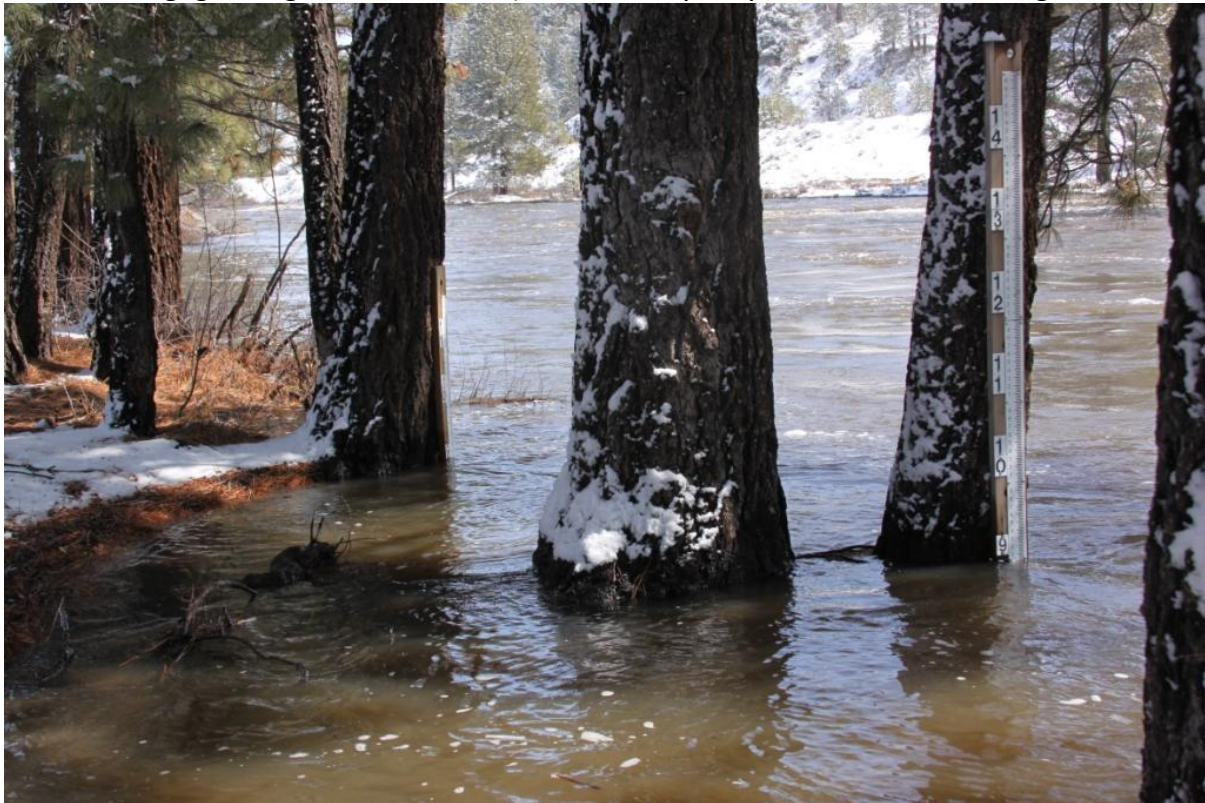
Upper MFTC1 staff gage, range: 7.4'-15.0', 3/17/2011, 1245PM; Stage: 9.01', Flow: 4820 cfs

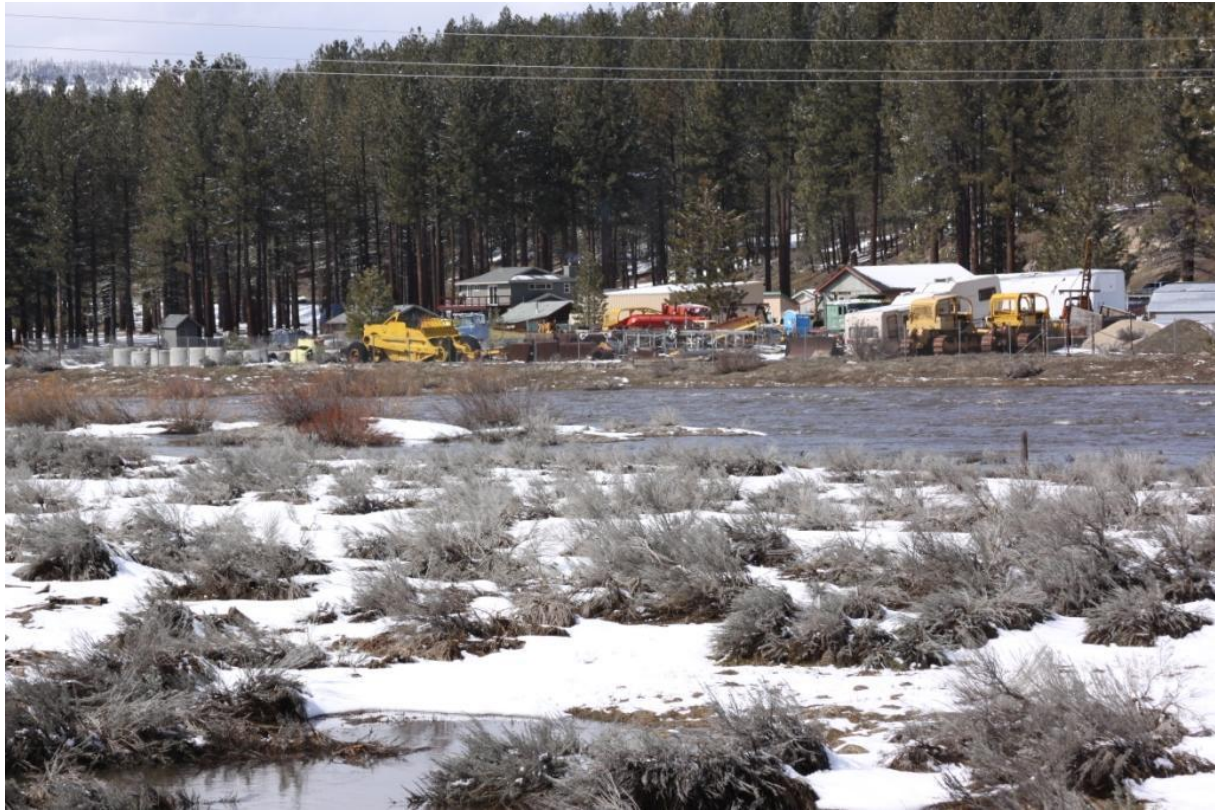
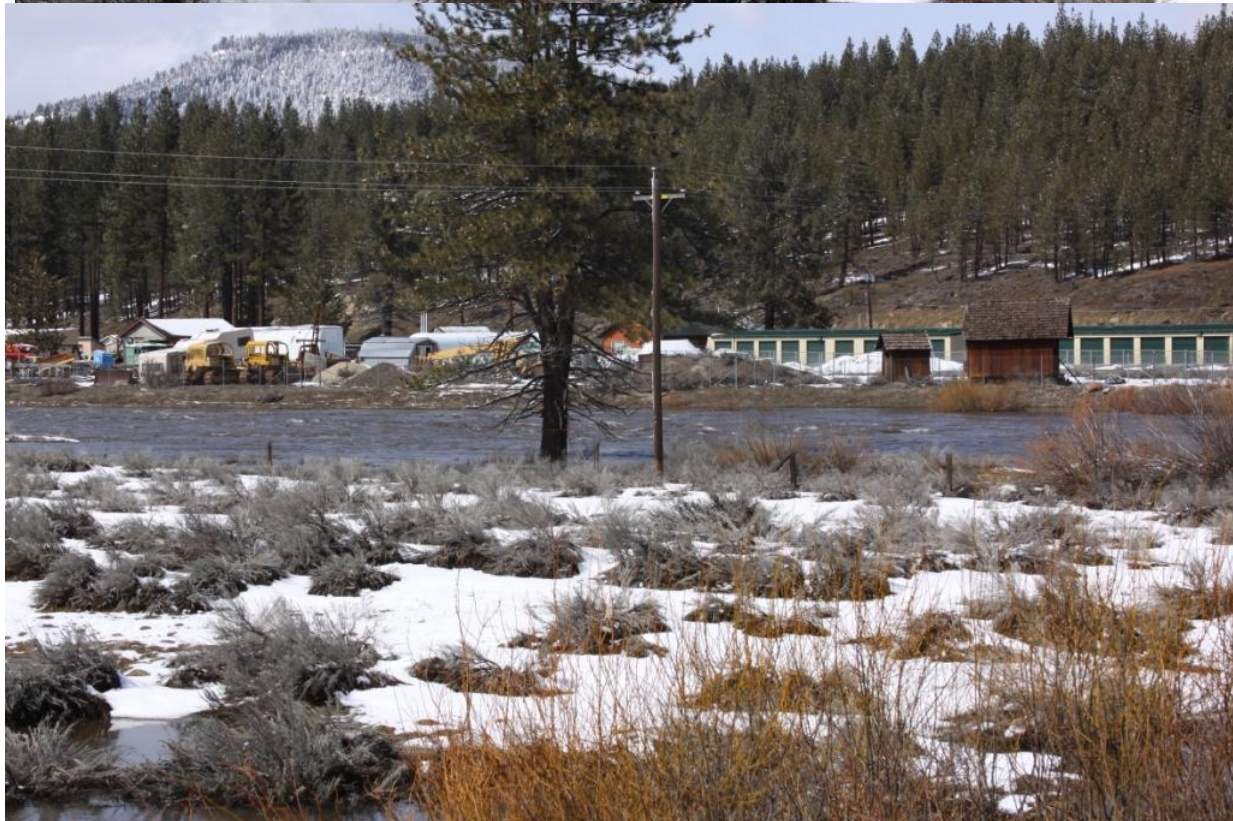
Photos: Middle Fork Feather River near Portola, CA: During 3/17/2011 High Water

Two views (top to NNE, bottom to NNW) of businesses/heavy equipment/storage facilities on RB in Portola. Structures est. ~2' to 3' above river level this day. Taken from across river at sewage ponds on LB; 3/17/2011, 1:40PM. Stage/flow @MFTC1 gage: 8.99'/4790 cfs.

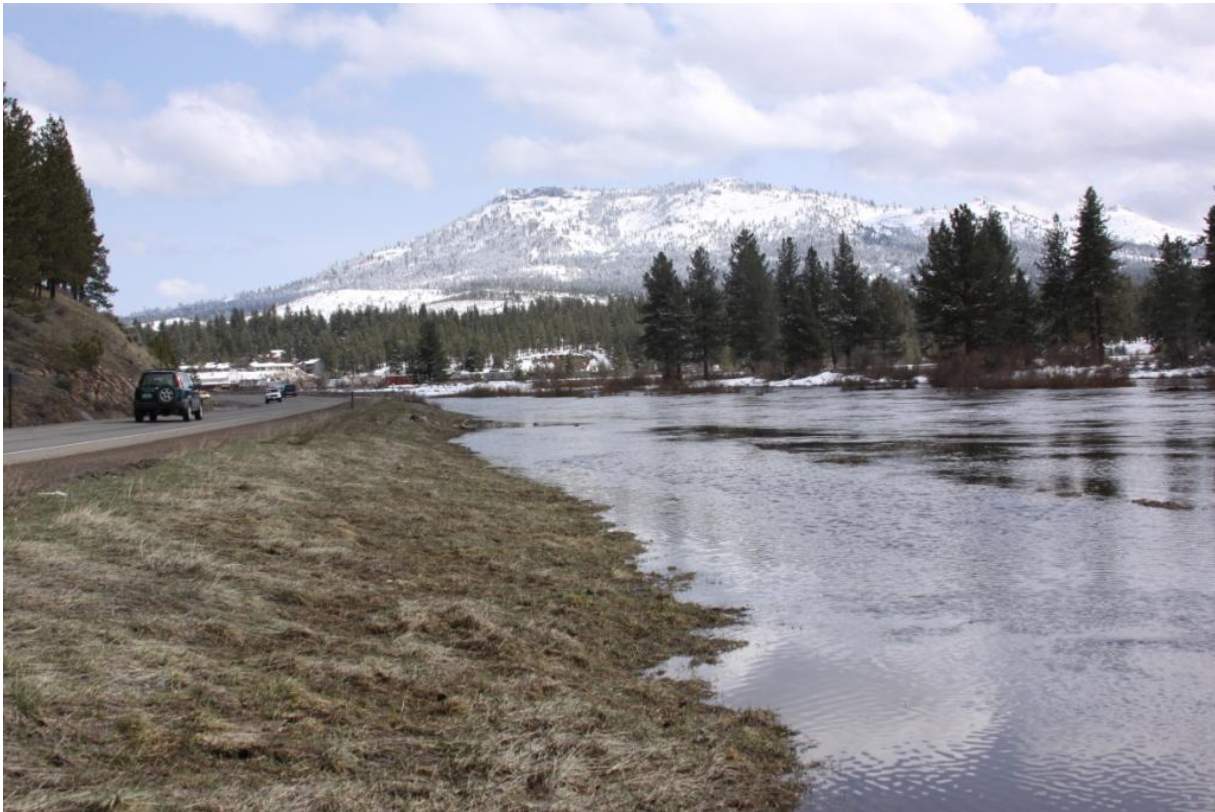
Photos: Middle Fork Feather River near Portola, CA: During 3/17/2011 High Water

View ESE (US) toward Portola and Beckwourth Peak (7252', in background) from RB, @ CA Hwy 70 Mile Marker 75; across river from sewage ponds. 3/17/2011, 2:45PM. Stage/flow @MFTC1 gage: 8.97'/4760 cfs.

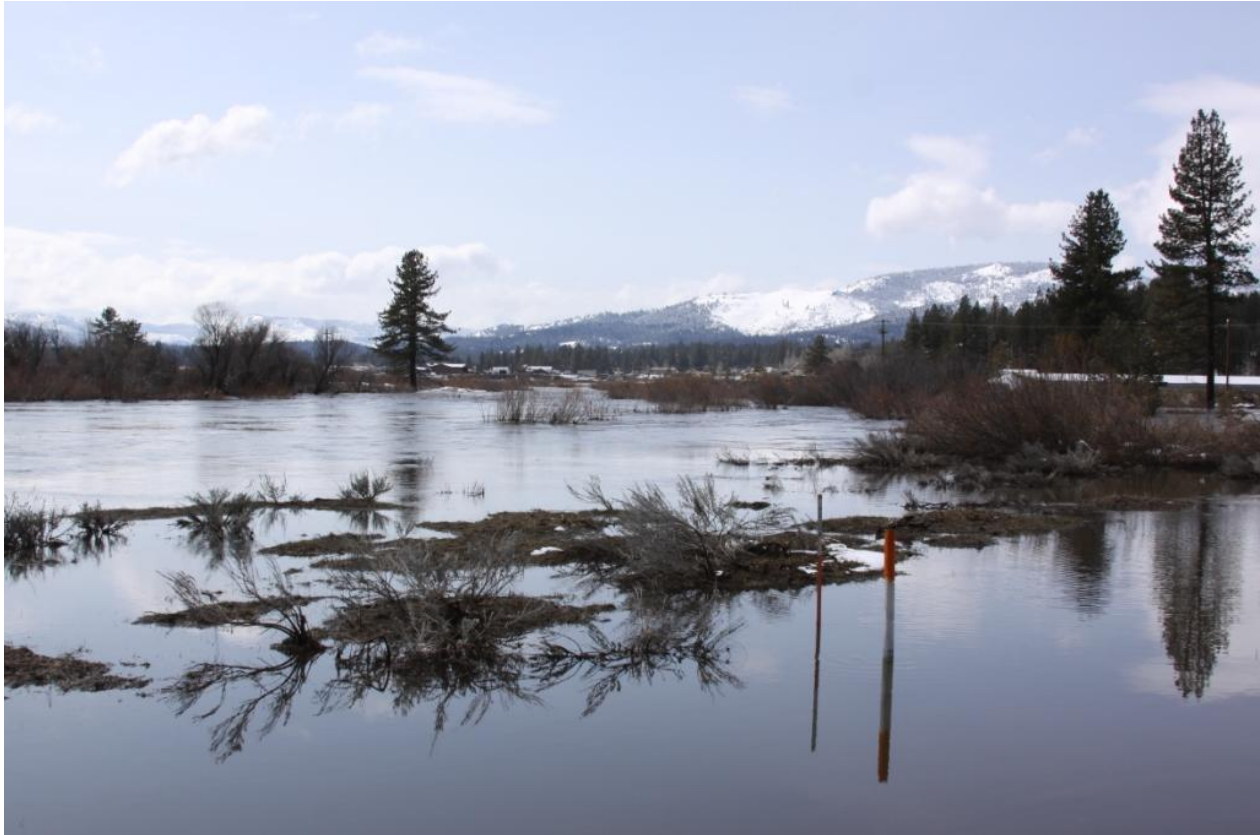
View WSW (DS) from RB, @ CA Hwy 70 Mile Marker 75. 3/17/2011, 2:45PM.
Stage/flow @MFTC1 gage: 8.97'/4760 cfs.
